Understanding the Geologic Background for the September, 2008 Flooding Event that Led to the Temporary Closure of IU Northwest

Erin P. Argyilan, PhD
Department of Geosciences

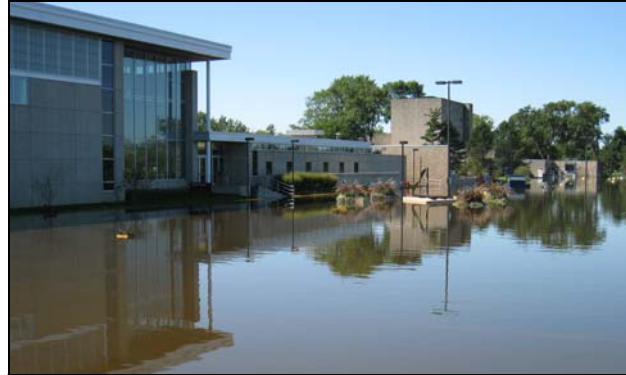
Figure 1. Flooding of the main parking lot on the north side of campus. (Photo by E.P. Argyilan)

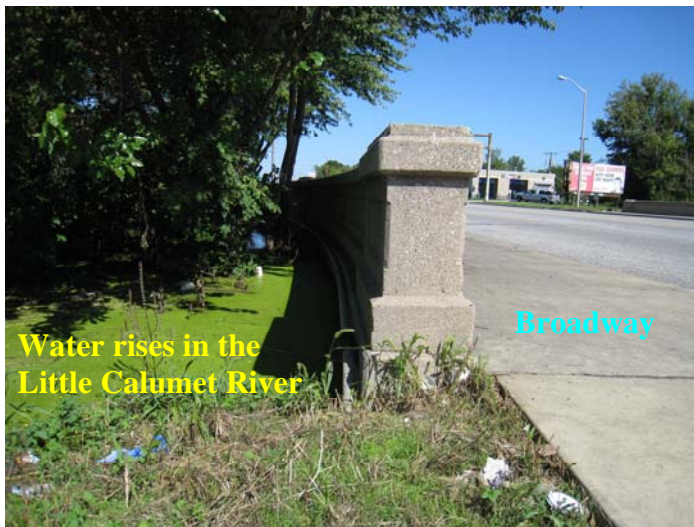
Figure 5. Water level in the Little Calumet River rose to the level of Broadway. Photo by E.P.Argyilan

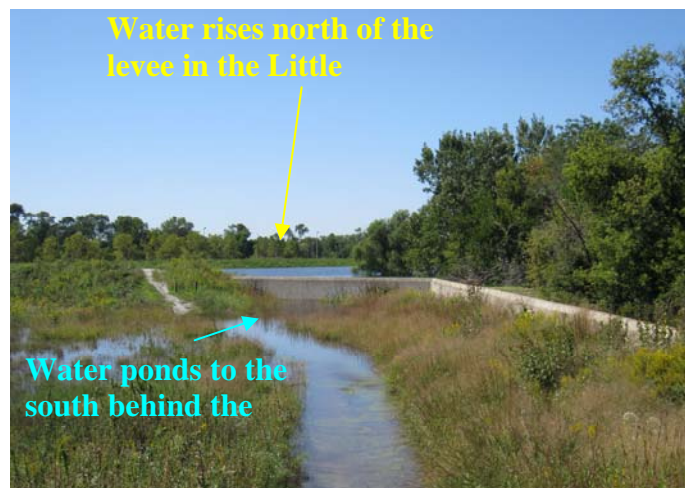
Figure 6. As water level rose within the levees of the Little Calumet River the water table also rose and caused ponding south of the levee system Broadway. Photo by E.P.Argyilan

But just as waters rose in the Little Calumet River, water also rose up in to the parking lot. A look in the USGS monitoring well adjacent to the parking lot will show that throughout the year the water table remains within inches of the level of the parking lot. With a rain event, infiltrating water causes the water table in the ground to rise causing flooding of the parking lot. During the September event, the excess water could not infiltrate the already saturated soils. At the same time, with water levels so high in the Little Calumet River, the storm and sanitary water system could not drain the water but actually backed up through the manholes.
